Monara has two 6-cylinder Gardner engines, and through 4.7m long 3" diameter bronze propeller shafts, both propellers are driven.

When we broke our port propeller shaft, only 12 hours after we left our Antwerp

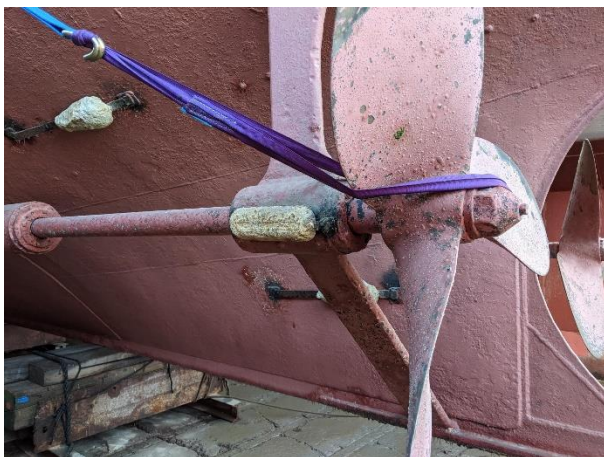
berth and heading for Kirkwall, we did notice that the housing of the stuffing box was hot. After releasing some pressure on the packing material, and allowing water to drip in, the stuffing box did cool down.

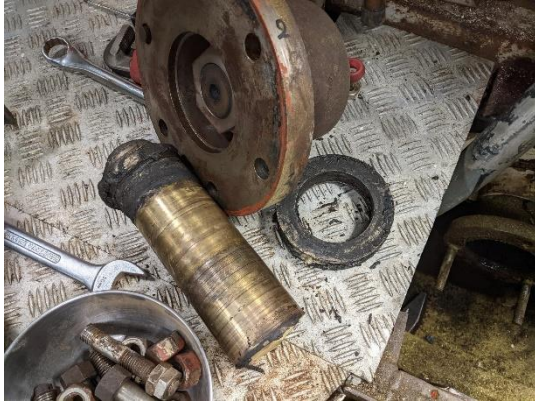
Something in the shaft tunnel was preventing the shaft from moving. By cutting some slices out, we could get the broken part out.

The shaft was snapped off just aft of the stuffing box and the cooling water injector. It showed pressure cracks and deformations as a result of extreme torque, and the broken end was shaped like a mushroom.

Once the expanded parts were removed, the shaft came out relatively easy. Apart from the mushroom shaped deformations where it broke, the shaft showed no marks of extreme wear at the bearings.

An insurance expert who came along, noticed that the seawater cooling to the shaft was blocked. We assume that as a result of lack of cooling, the shaft overheated, expanded or deformed, and blocked itself in the shaft tunnel.
