Monara has two 6-cylinder Gardner engines, and through 4.7m long 3" diameter bronze propeller shafts, both propellers are driven.

When we broke our port propeller shaft, only 12 hours after we left our Antwerp

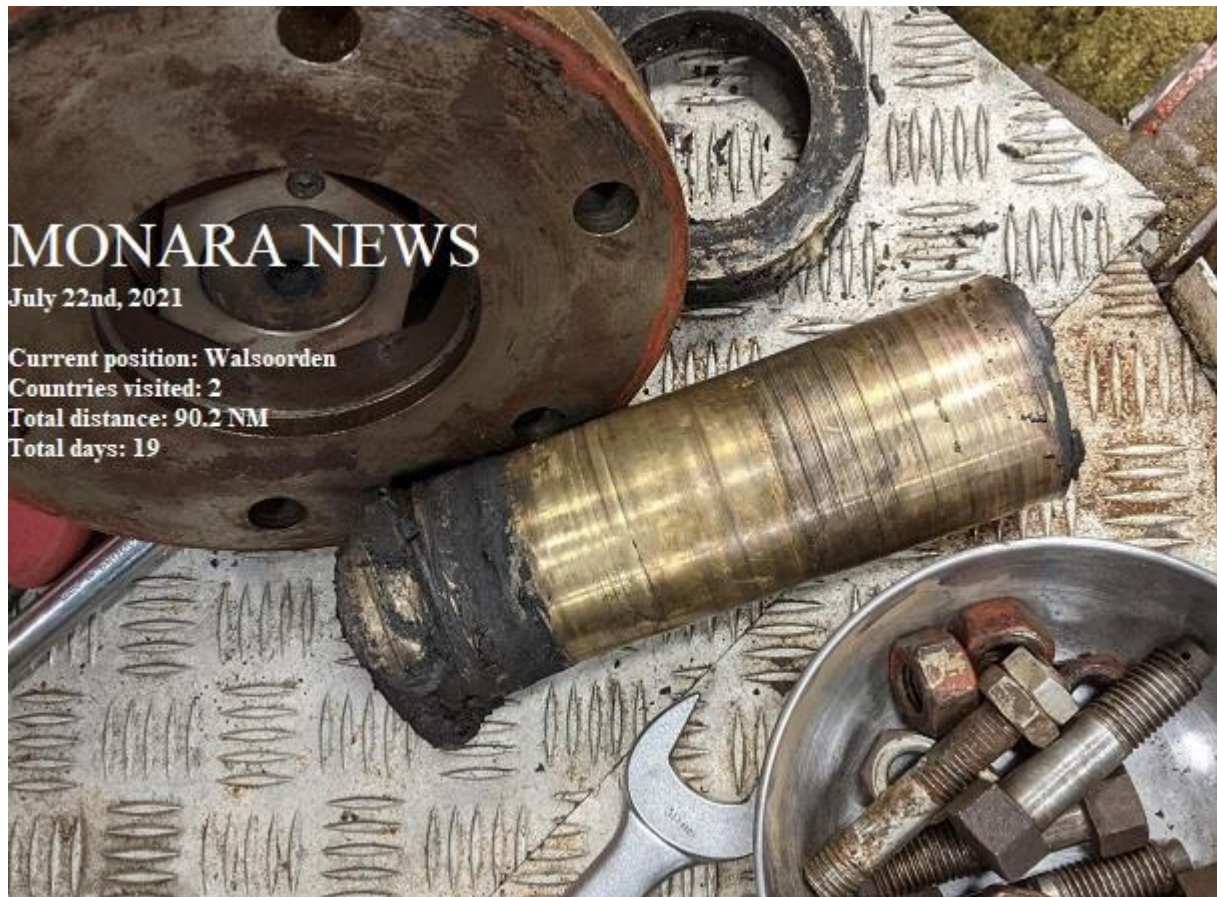
Over the last 5 years we have travelled 15000 NM with Monara, and along the way we have come across all kinds of hick ups, but I dare say that this one has baffled me most.

berth and heading for Kirkwall, we did notice that the housing of the stuffing box was hot. After releasing some pressure on the packing material, and allowing water to drip in, the stuffing box did cool down.

The shaft was snapped off just aft of the stuffing box and the cooling water injector. It showed pressure cracks and deformations as a result of extreme torque, and the broken end was shaped like a mushroom.

Once the expanded parts were removed, the shaft came out relatively easy. Apart from the mushroom shaped deformations where it broke, the shaft showed no marks of extreme wear at the bearings.

On a short notice the shipyard did find an 80mm diameter stainless steel shaft of 6m long, which was machined to size for us, and special
