04/05/2016 - Antwerp Moordtgat docks

When bringing Monara to her new home in march 2016, we noticed a lot of drag, and we further had to move the tiller 7 degrees to starboard to sail straight. Time for a thorough hull cleaning.

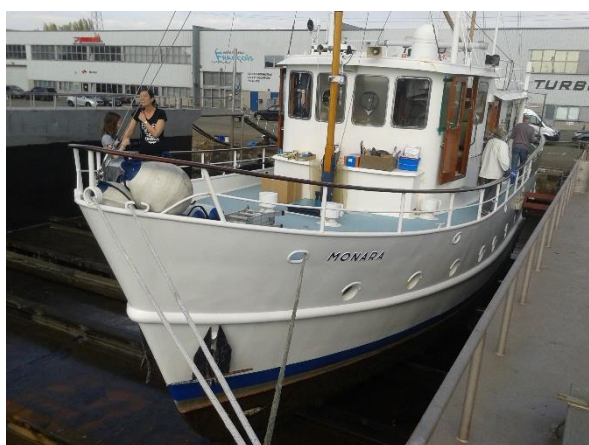
We move her in the drydock of Moordtgat in Antwerp, to have a look at her hull. The proud old lady comes up with a huge beard, covered in barnacles, enormous oysters, mussels and a large variety of other British marine life. Amazing that the food and drug administration didn't stop us on our way out of the UK for smuggling 'Fruits de Mer'.

We had to rent a 200 bar compressor to get some of it off. Most of the shells and barnacles would only let go under a pallet knife. Sanding with grade 40 to 60 takes off most of the barnacle footprints, although a lot of the calcium residu is hard to remove.

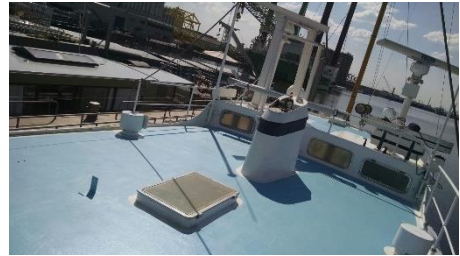
16 anodes of 10.6 kg, 6 anodes of 3.5 kg – 190 kgs of zink, to prevent the corrosion from coming closer!

We apply two layers of black and two layer of red Awlgrip Gold Label antifouling. The waterline gets a dark blue touch. The top deck needs some attention as well, so after scrubbing it down with a degreaser, she gets a fresh layer of Interdeck 925 squall blue.
